Building N-226 Reuse Guidelines

NASA Ames Research Center, California

Architectural Resources Group

October 2007

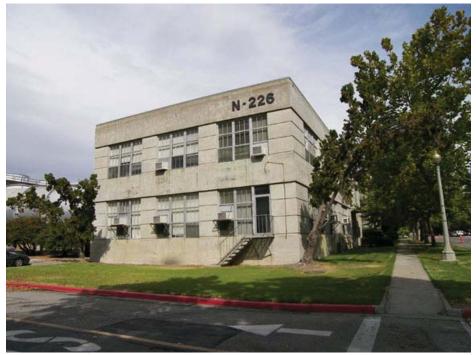
View of the East and South Elevations of Building N-226.

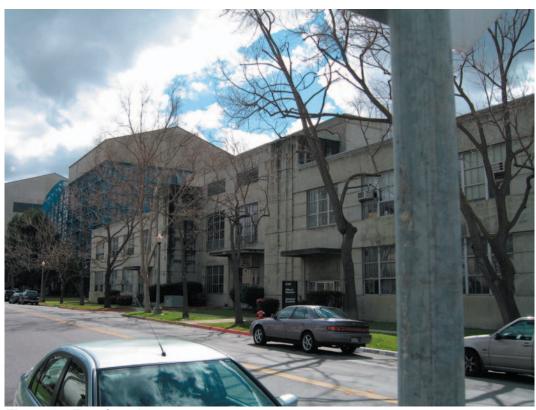
The front (east) elevation features a central slightly recessed element measuring approximately 47 ft. tall and flanked on each side by a long wing. The recessed façade contains double doors that lead to the ground floor model shop space that now serves several miscellaneous uses. Above the entrance is a precast mittered concrete panel that is now partially covered with signage displaying "NASA 6 by 6 Foot Supersonic Wind Tunnel." The original pre-cast panel most likely displayed lettering reading "NACA" indicating the building was originally constructed during the administration of the National Advisory Committee on Aeronautics (NACA). Above the double doors is a cantilevered concrete canopy featuring rounded corner edges indicative of the Streamline style. The central façade contains eight windows; two on the ground floor, three on the second floor, and, three rectangular shaped louvered windows above the second floor windows.

Figure 8. East façade

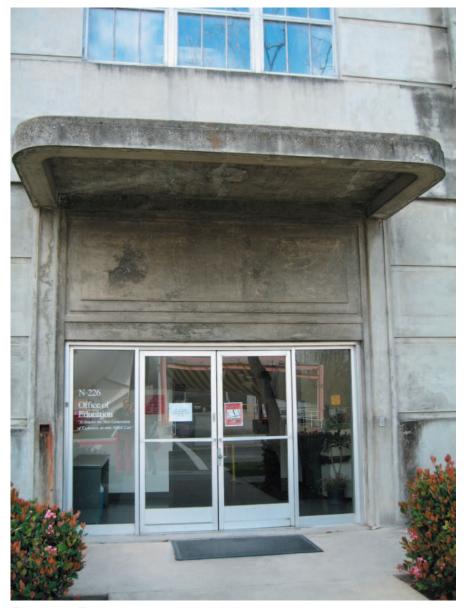
Figure 9. East proposed accessible entry

Recommendation: Provide disabled accessible path of travel from the parking area to the front entrance. Modify the existing entrance to the south wing to allow for disabled accessible travel to first floor level. Provide disabled access to the second floor level by means of an elevator or other vertical access system. Recommend study of the use of the existing freight elevator as a possible passenger elevator location, or other central location within the building. At the test chamber room, disabled access to the western portion of the room is necessary if the room continues to be used in its current arrangement.

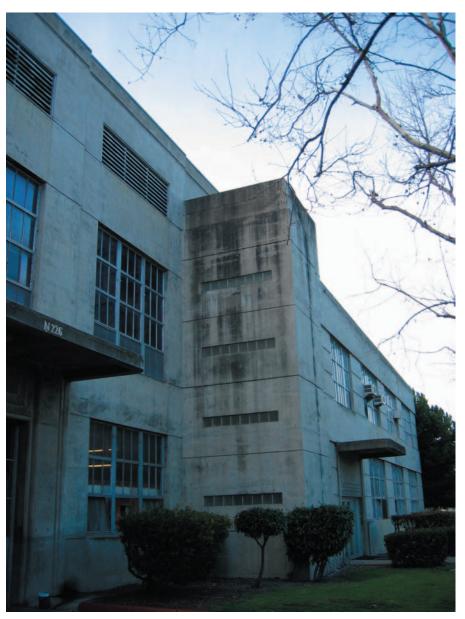
Figure 10. East entries and restroom tower with glass block band windows

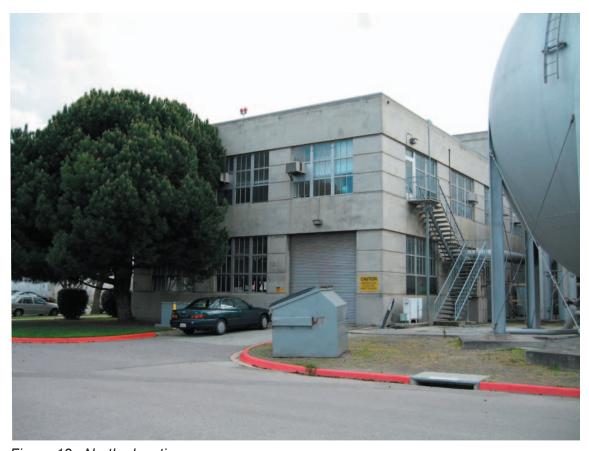
Figure 12. North elevation

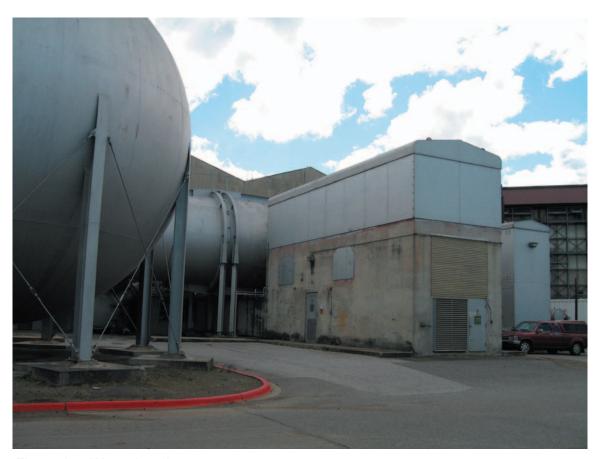
The exterior body of the wind tunnel and its related machinery obstructs view of the building's rear (west) elevation. This includes the cooling coils, the compressor and the drive motors.

Figure 14. West elevation

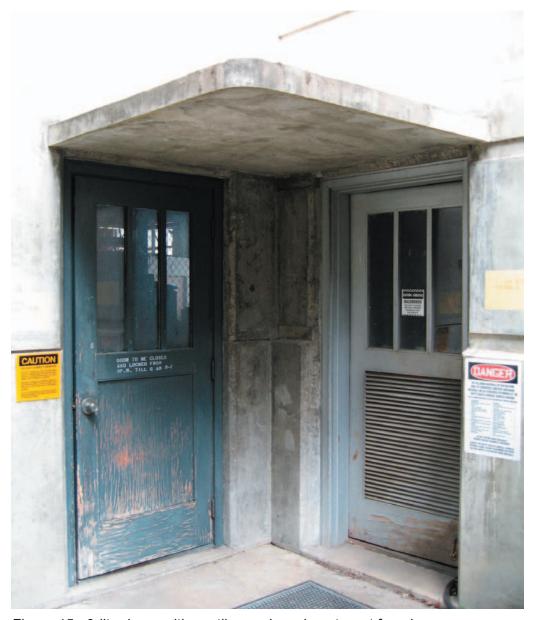
Cantilevered streamline style concrete canopies with rounded corners over doors	S	P	spalling and deterioration
Ornamental banding (over doors and below canopies at wings)	S	P	spalling and deterioration
Ornamental striping (center block parapet)	S	G	
South Elevation			
Concrete surface articulated with classical style striping, emphasized horizontality	S	G	stained
Windows			
Multi-lite metal sash windows with operable hopper segments (wing and center block beyond)	S	F	one modified to provide an exit door; window mounted air conditioners
Doors:			
Single-lite metal door with transom (infilling one section of multi-lite metal sash window)	N	G	
3-lite 1-panel wood door with cantilevered awning (center block)	S	P	
Ornamental striping (center block parapet)	S	G	
Cantilevered streamline style concrete canopy with rounded corners over doors at the corner (center block)	S	P	spalling and deterioration
West Elevation

Figure 15. 3-lite doors with cantilevered awning at west façade

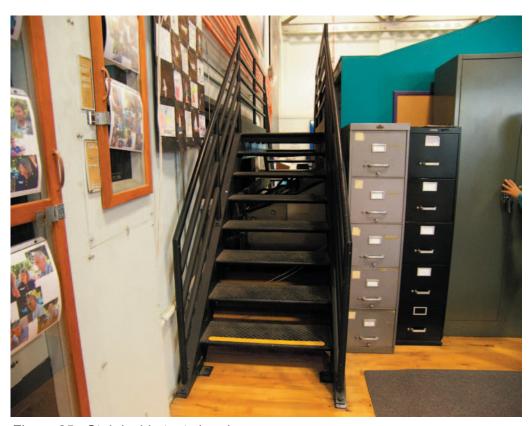
Figure 25. Stair inside test chamber room

Recommendation: At the egress stair from the Test Chamber (southwest corner of room) provide an exit enclosure that leads directly to the exterior, the existing exit door at the first floor could be used for exiting to the exterior. At the emergency exits at the Second Floor offices, provide compliant stairs, handrails, and guardrails to replace the existing steel ladder that leads to the emergency exit at the windows.
